## FIELD INSPECTION REPORT

<b>Project Name:</b>	Mountain Valley Pipeline	<b>Inspector:</b>	Matthew Grant
<b>Inspection Date:</b>	Wednesday, February 19, 2020	<b>Project Contact:</b>	Brian Clauto,
<b>Spread I: Franklin</b>	MP 279.3-278.8 ATWS 372	<b>Weather:</b>	Wet

## FIELD INSPECTION PHOTO LOG

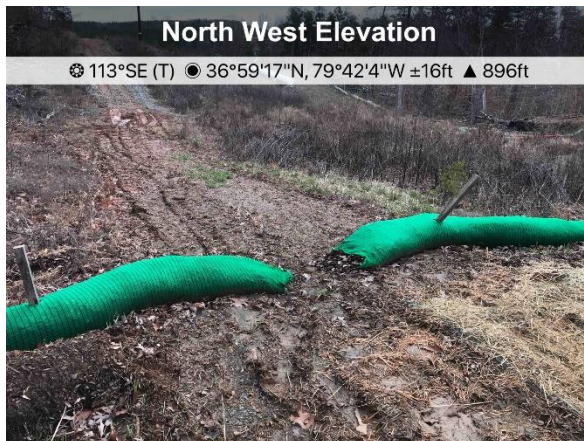
- St14750+00 bank requires stabilization
- St14722+00 CFS has been bypassed at sump
- St14722+00 reeling has occurred and has affected the ECD; repairs/stabilization is required
- St14722+00 CFS at landowner road has been damaged and requires repair

- Figure 5: St14722+00 CFS at landowner road has been damaged and requires repair

**Recommended Corrective Action:** Maintain and install all controls per the approved PSS&S.

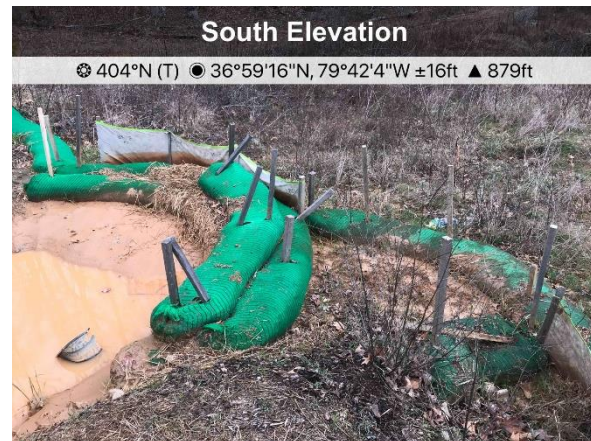
- Figure 6: St14722+00 CFS has been bypassed at sump

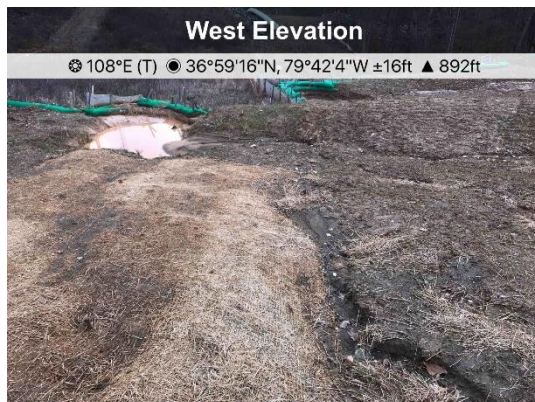
- Figure 7: St14722+00 reeling has occurred and repairs/stabilization is required
